Coal Combustion Waste Impoundment Round 5 - Dam Assessment Report

Plant Wansley (Site # 006)
Ash Pond Separation Dike

Georgia Power
Carrolton, Georgia

Dewberry & Davis, LLC
Fairfax, Virginia

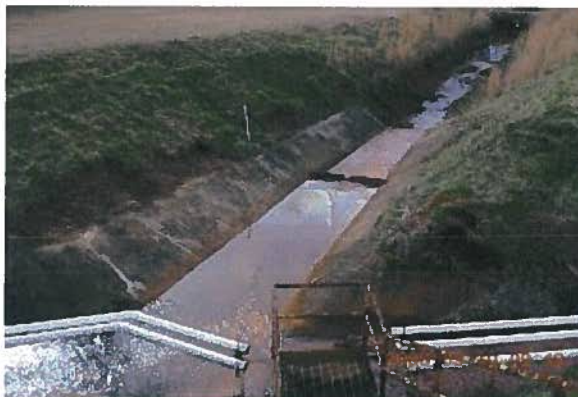
Pt. 140 (~Sta. 57+00) – Build-up of silt at weir. **Clean out dirt around weir.**

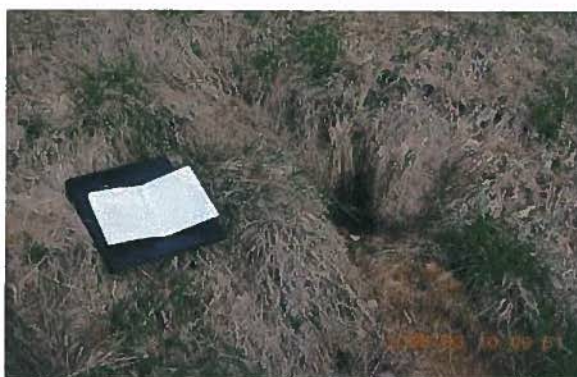
Pt 141 (~Sta 53+00) – **Animal burrow needs to be filled in.**

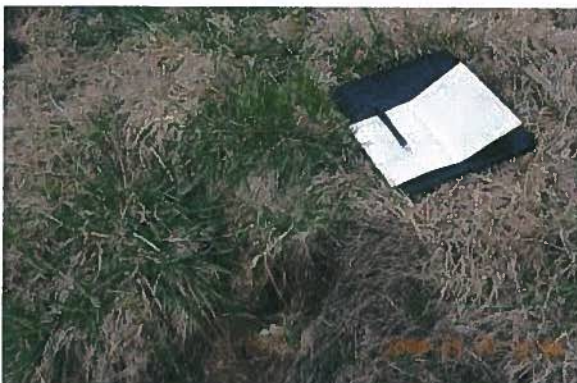
Pt. 142 (~Sta. 45+00) – **Three animal burrows at headwall need to be filled in.**

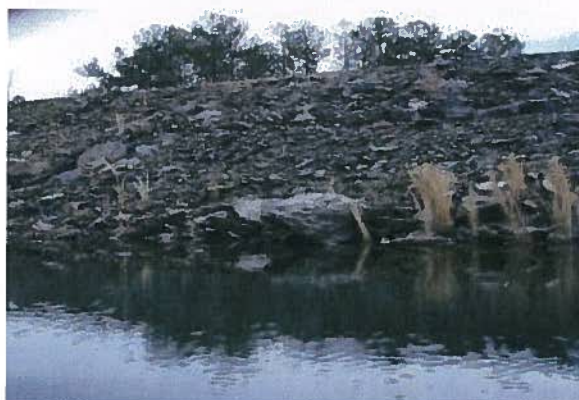
Pt. 143 (approx Sta. 40+00) – **Rip-Rap on upstream slope of main dike.**

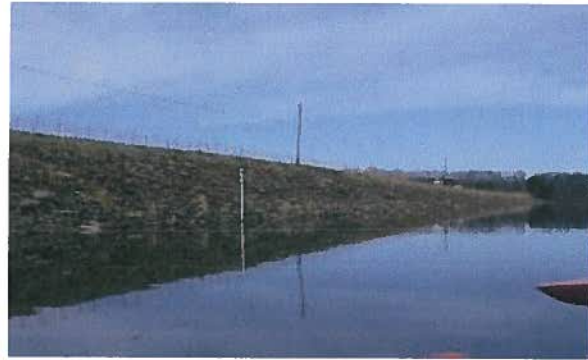
Pt 144 – Rip-Rap on upstream slope of separator dike.

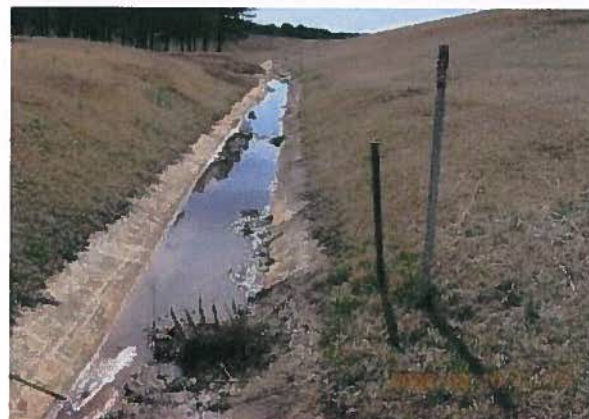
Pt. 145 – Sta. 1+00 to 8+00 – Clear debris from finger drains at Sta. 1+00 & Sta. 7+00 and clean out bottom of concrete lined channel of silt/sand and miscellaneous.

(Note: Pt. 146 – not shown on plan – same comment as Pt. 147 below)

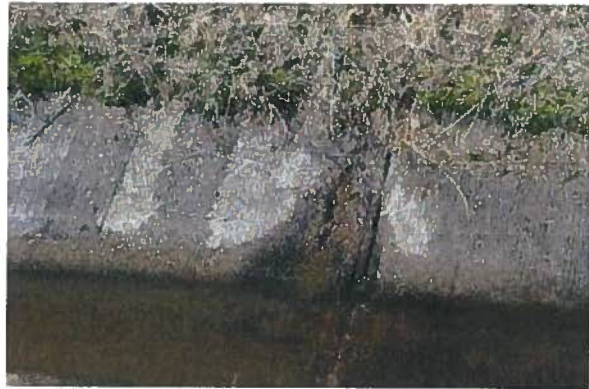
Pt. 147 – Minor seepage into concrete channel (~ Sta. 12+50).

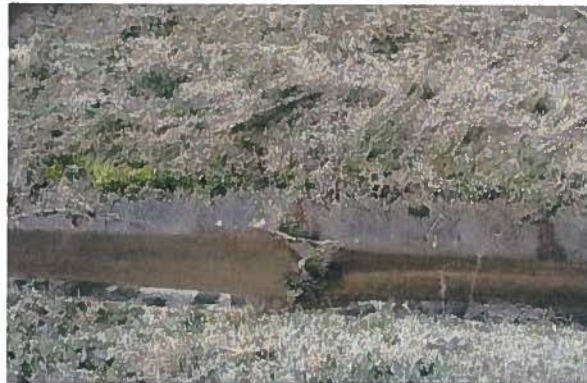
Pt. 148 (~Sta. 15+00) Finger drain dry, but localized seepage into channel. **Localized grass in channel needs to be removed.**

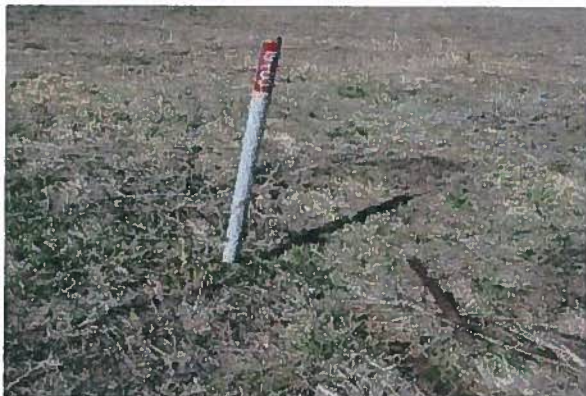
Pt. 149 – (Sta 19+00) – **Finger drain blocked at this location and needs to be cleaned out.**

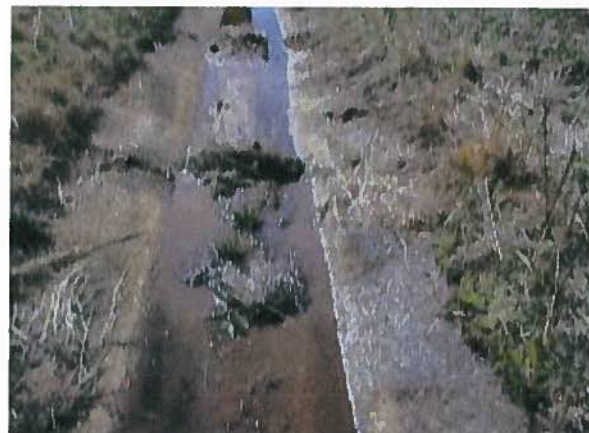
Pt. 150 – Build-up of grass and debris in channel, (restriction of flow through channel). **Debris/grass needs to be cleaned out of channel**

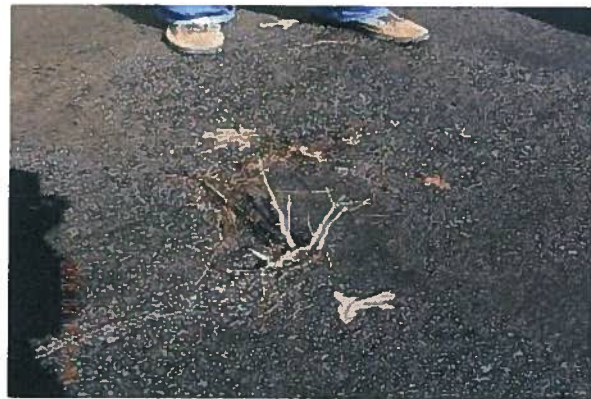
Pt. 151 – Localized minor vegetation observed at floor of spillway. **Remove vegetation from weephole and other various locations in the spillway floor.**

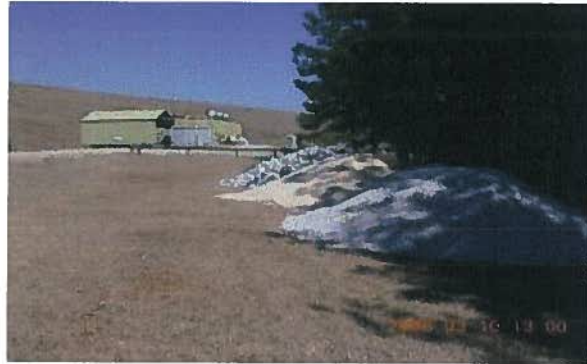
Pt 154 – Stockpiles of emergency coarse and fine aggregate drainage materials looks good

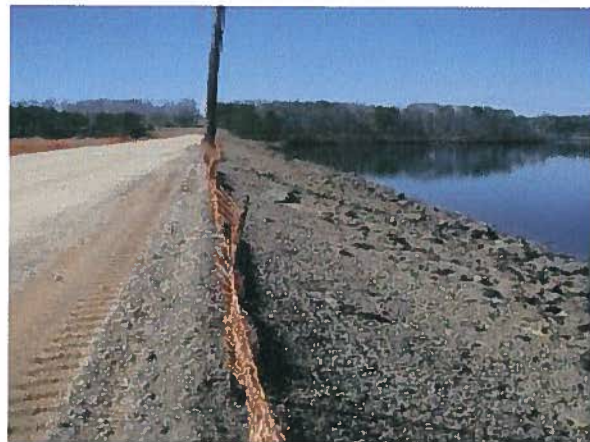
Upstream slope generally looks satisfactory although surface runoff is causing localized erosion near top of slope.

Localized re-grading required to flatten over steepened upper portion of slope and to provide positive drainage to minimize over-slope flows (which will result in progressive erosion along slope)

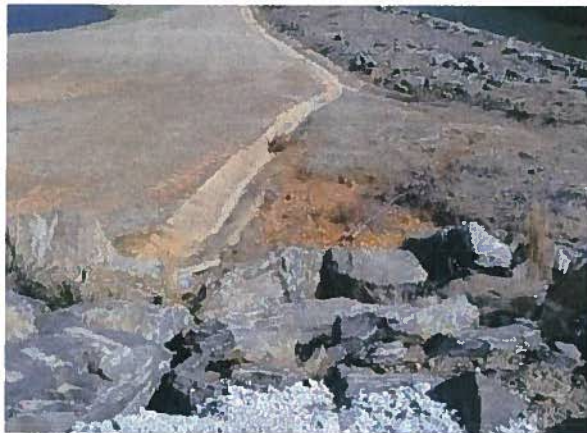
Localized bare spots on slope. Repair either by re-seeding to re-establish grass cover or place small rip-rap/stone).

092 The upstream slope of the dike is rip rapped. There is a fair amount of grass growing in the riprap. **This grass should be poisoned.** There is a stand of brush along the upstream edge of the dike. **This brush should be removed.**

(See Updated Status from Third Quarter Report –Location 092, for items to be completed)

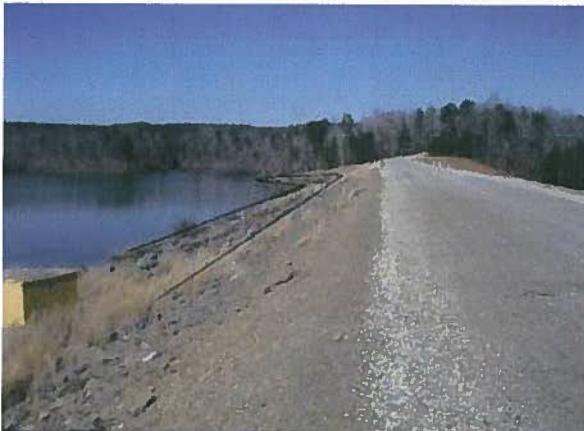
Vegetation growth at toe of upstream slope. Cut down and remove vegetation (grass/bushes)

089 An eroded area was noted on the downstream slope just east of the spillway. This appears to be the result of runoff from the roadway passing through the riprap and running down this area instead of into the adjacent paved ditch. It would be a good idea to add some rock to the eroded area to protect it from further erosion and to add some rock to the riprap at the top of the slope to try to direct the runoff into the existing paved ditch. There are also some small trees growing in this area. These should be cut or poisoned.

(See Updated Status from Third Quarter Report – Location 089, for items to be completed).

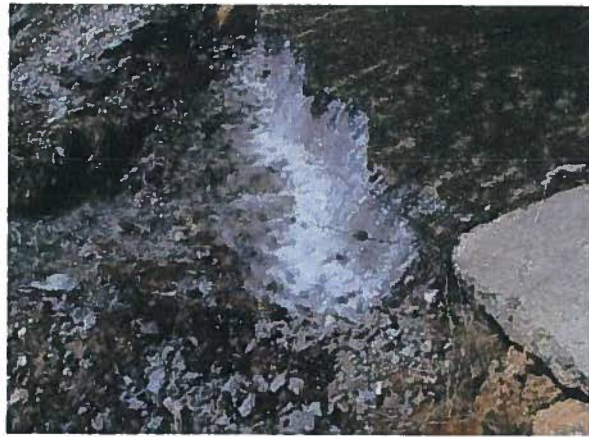
Repair of downstream outfall completed

094 The downstream outfall for the paved ditch has been undermined. Storm flows from the ditch undermine the ditch liner and will eventually remove the soil supporting the end of the ditch liner causing the liner to fail. **This area should be reinforced by placing Type I riprap in the pond at the outfall and choking that with Type III riprap. See sketch below.**

(See Updated Status from Third Quarter Report – 094).

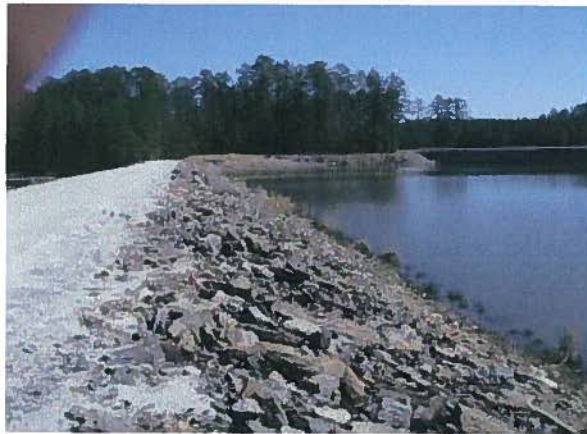
Rip-rap on upstream and downstream slopes overall looks good. No evidence of recent erosion or instability. Brush has been cleared since 3rd Quarter 2007.

095 The upstream spillway of the paved ditch has been repaired with Type III riprap, but **the riprap needs to be dressed to match the contours of the paved ditch**. The current layout could result in uneven flows over the riprap and subsequent erosion

(See Updated Status from Third Quarter Report – Location 095, for items to be completed).

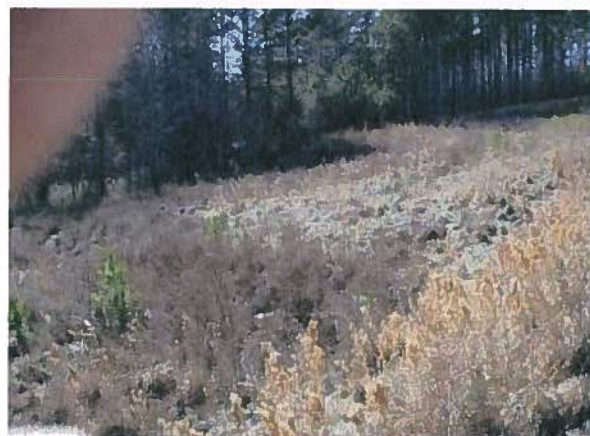
Vegetation on downstream slope.
**Remove/cut down
vegetation/brush/small trees for a
distance of 30 ft. out from toe of slope.**

099 The tall grass and small trees growing on the downstream side of the dike should be cut for a distance of 30 feet out from the toe. **3-10-08 – No work yet.**

(See Updated Status from Third Quarter Report – Location 099, for items to be completed).

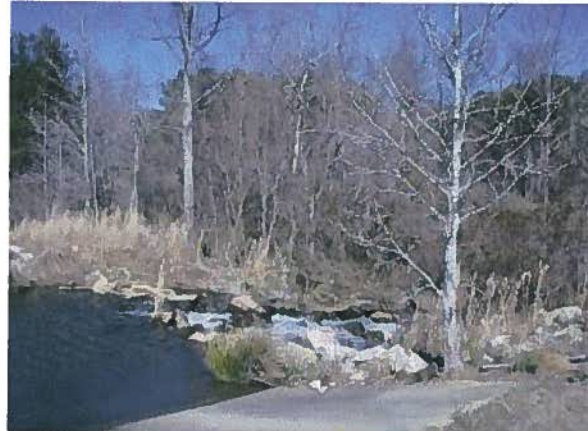
Tree and brush adjacent to spillway should be cleared.

100 The tree and brush growing adjacent to the edge of the spillway should be cleared. **3-10-08 – No work yet.**

(See Updated Status from Third Quarter Report – Location 100, for items to be completed).

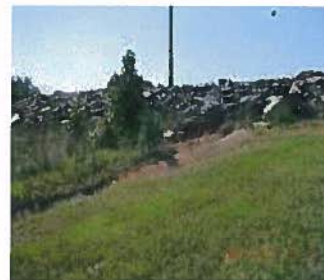
3-10-08 – Trees and bushes removed and gravel placed in rip rap. Some additional rock required to cover bare spots

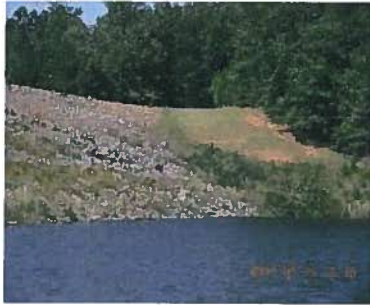
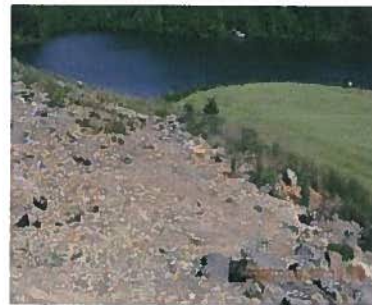
091 On the downstream side of the dike there is a growth of tall grass and woody brush along the east and west contacts of the dike with the natural ground. **This vegetation should be cut or poisoned. 3-10-08 – Brush cleared at both locations**

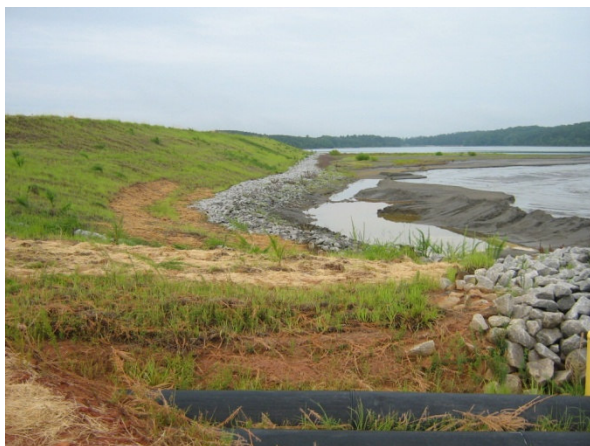
Photo 1: Upstream Slope adjacent to Gypsum Cells

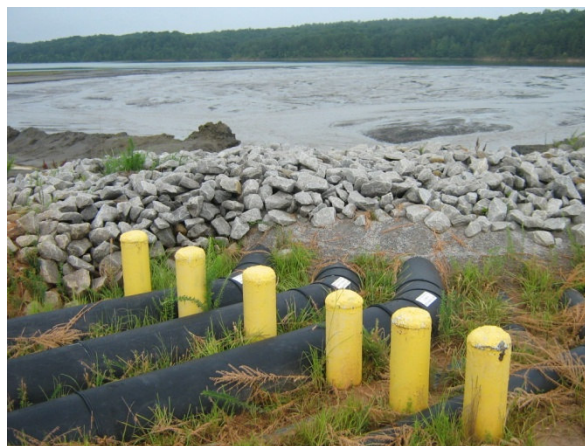
Photo 2: Ash Pond inlet

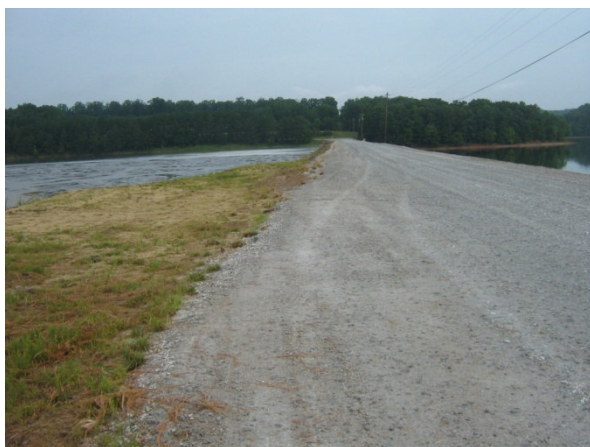
Photo 3: Separation Dike Crest facing North

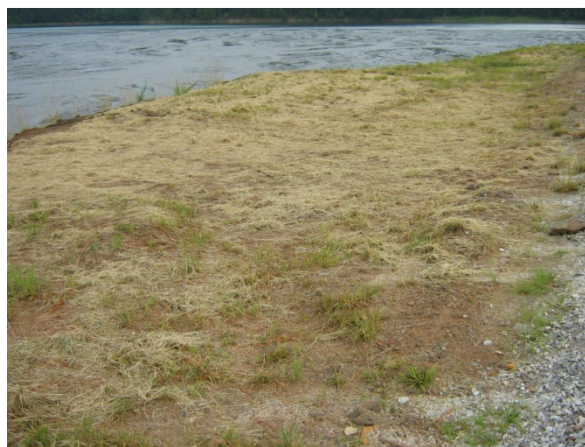
Photo 4: Close up where seeding occurred

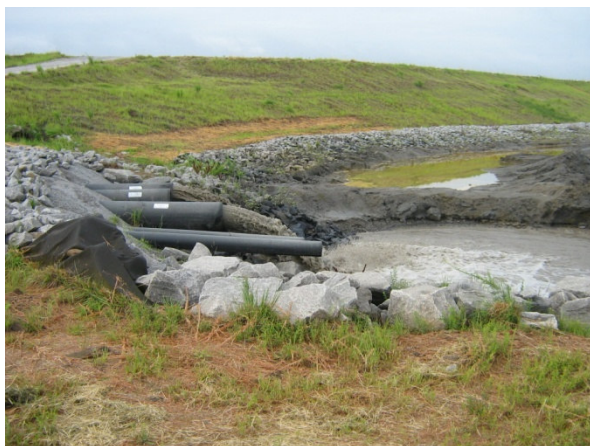
Photo 5: Ash Pond Inlet

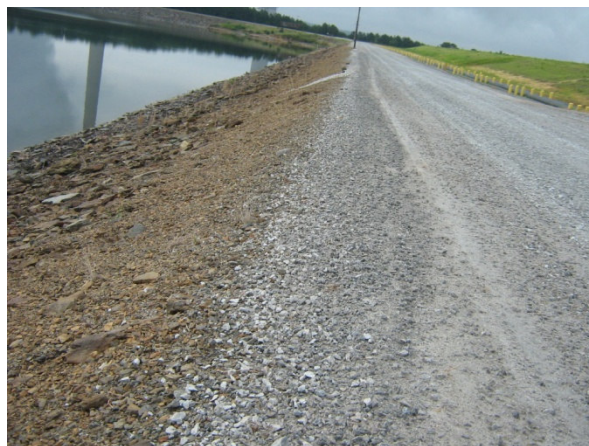
Photo 6: Separation Dike Crest downstream slope

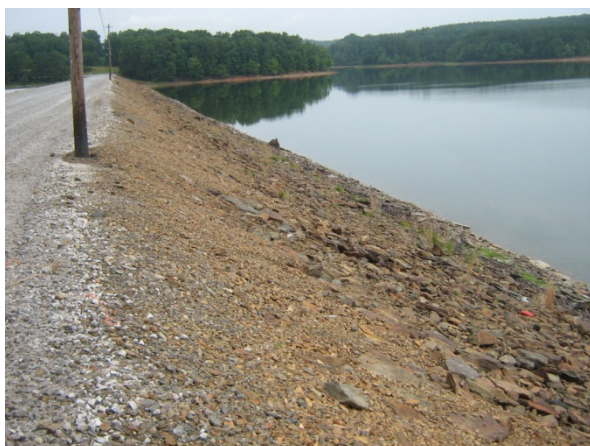
Photo 7: Separation Dike downstream slope

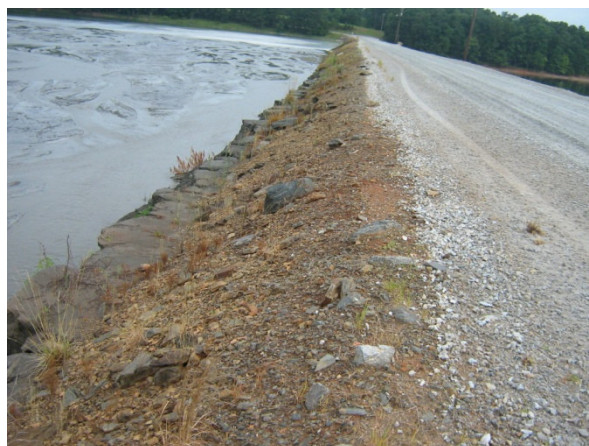
Photo 8: Separation Dike upstream slope

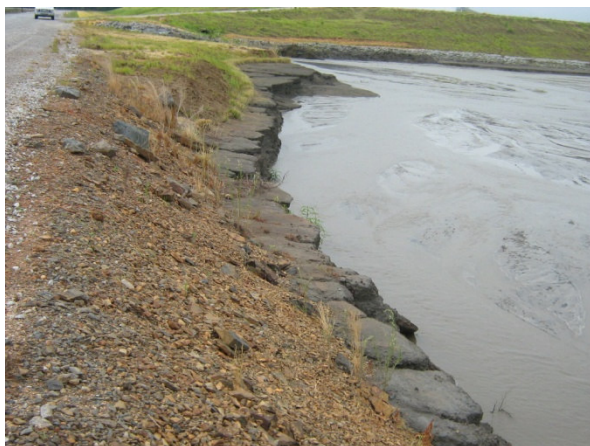
Photo 9: Separation Dike upstream slope

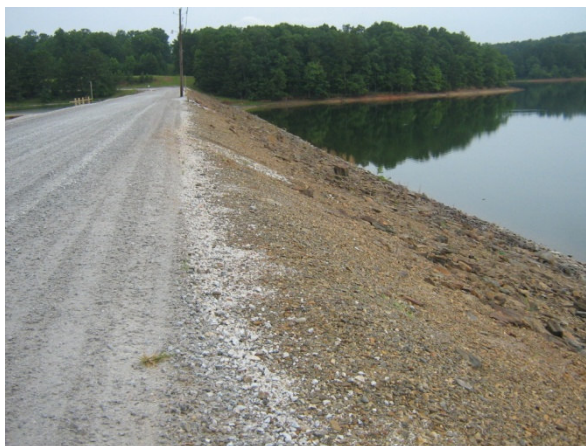
Photo 10: Separation Dike downstream slope

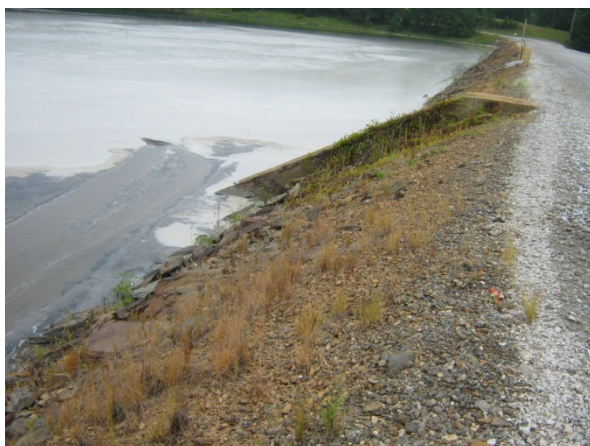
Photo 11: Separation Dike upstream slope

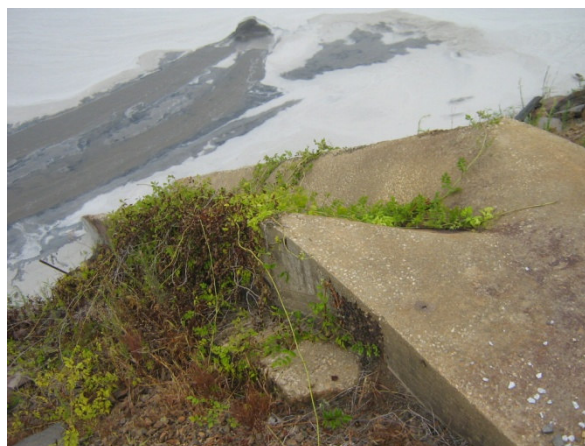
Photo 12: Concrete ash piping support (not in use)

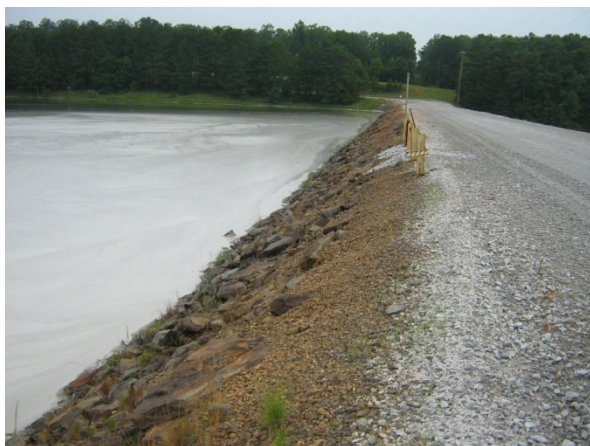
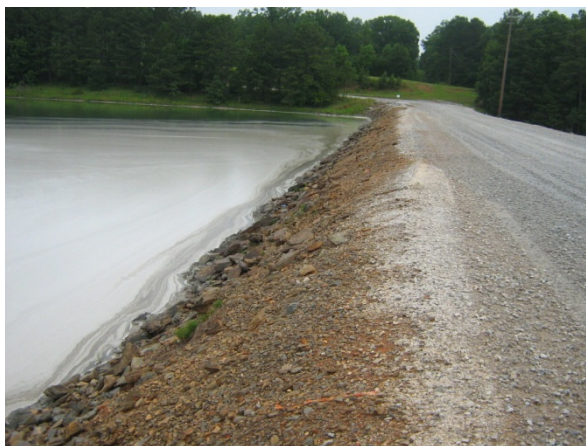
Photo 13: Separation Dike upstream slope

Photo 13B: Separation Dike upstream slope

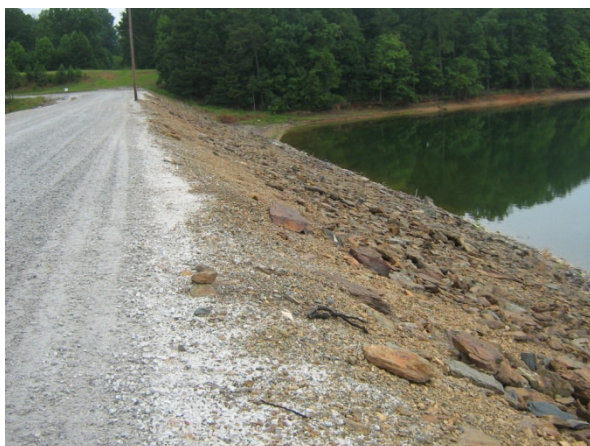
Photo 14: Separation Dike downstream slope

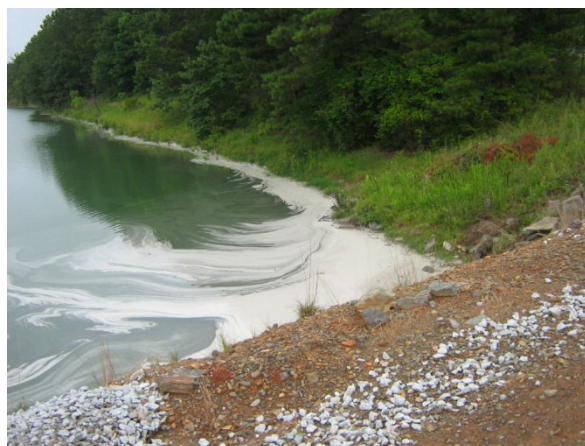
Photo 15: Separation Dike left abutment upstream side

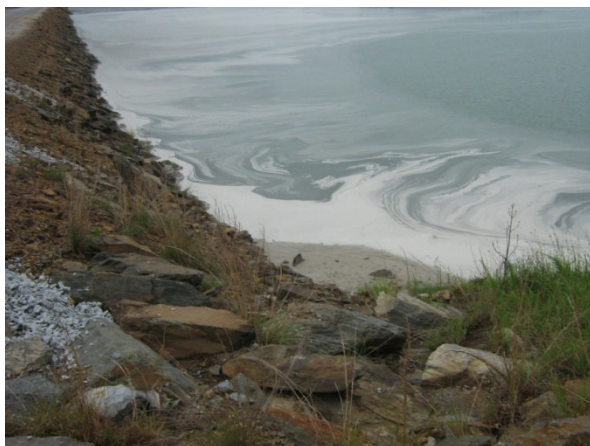
Photo 16: Separation Dike left abutment upstream side

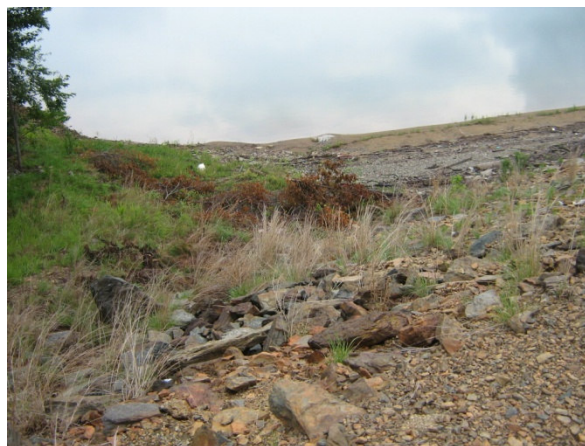
Photo 17: Separation Dike left abutment downstream side

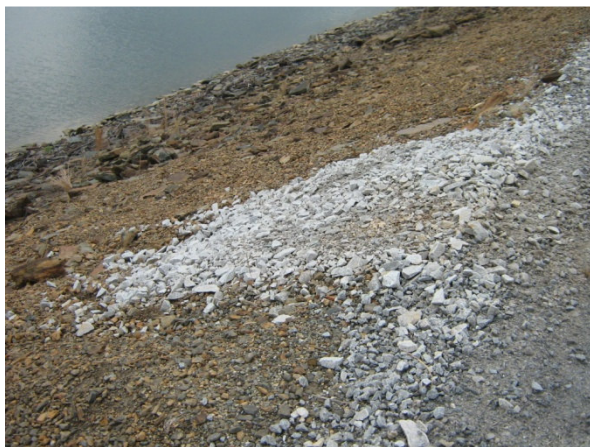
Photo 18: Erosion maintenance

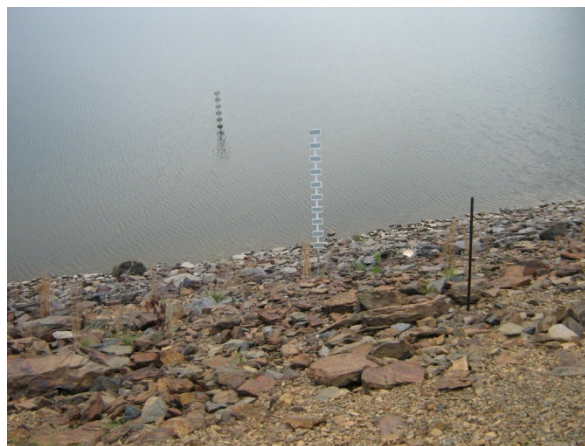
Photo 24: Downstream slope erosion repair

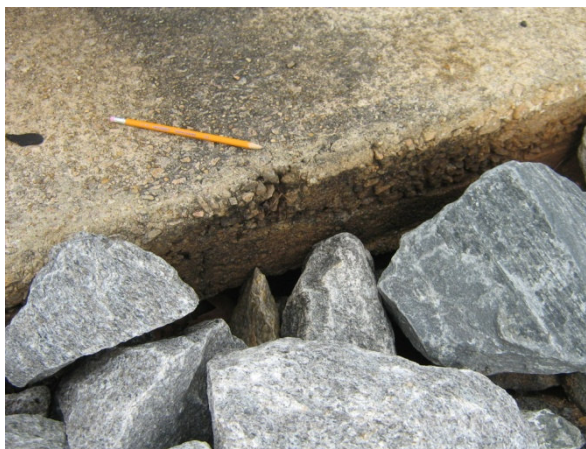
1. Daily, Weekly, Quarterly, and Annual2. N.P. WSE 795.015. Monitor U/S Undermining Potential & Cracks Along Concrete Channel (NOT A Safety Issue AT THIS TIME)20. No discharge from Pond (None observed historically)23. Cooling Water Pond & Storm Water Management Pond located Along D/S TOE of E & W dike respectively

Photo 54: Potential undermining at overflow

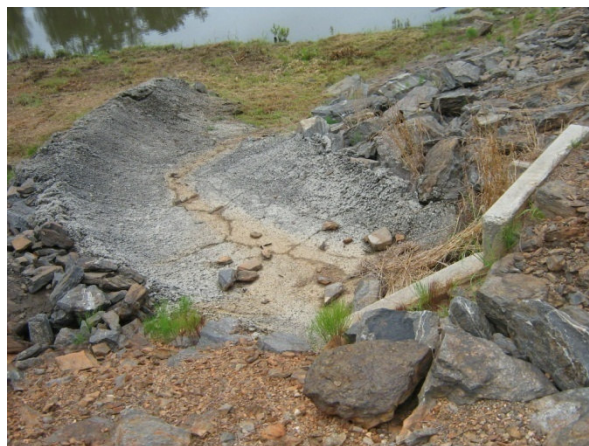
Photo 61: Western Dike outlet at Stormwater pond

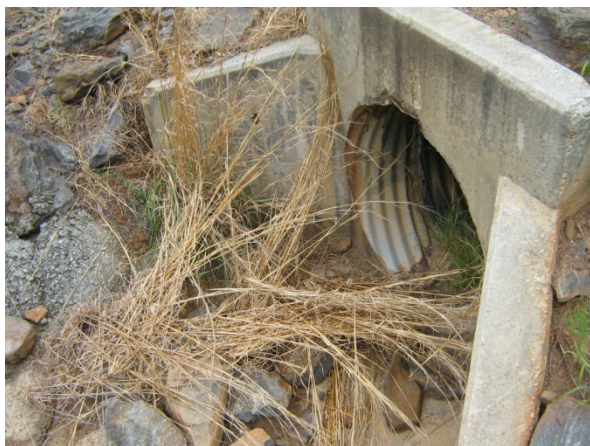
Photo 62: Outlet at Stormwater pond

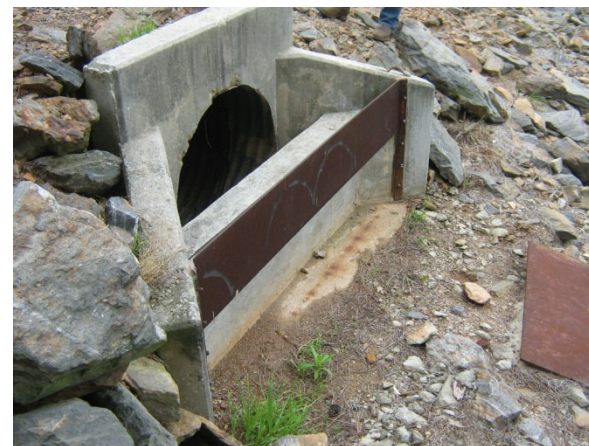
Photo 63: Western Dike outlet

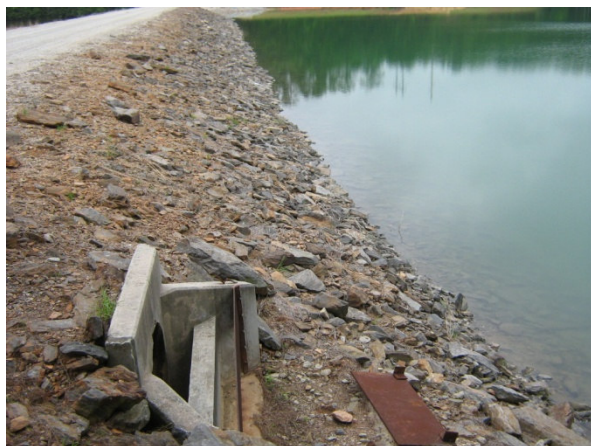
Photo 64: Western Dike upstream slope and outlet
